CYCLE TESTING OF ACS VALVES IN CLF₅ FINAL REPORT

TECHNICAL REPORT AFRPL-TR-72-82

AUGUST 1972

AIR FORCE ROCKET PROPULSION LABORATORY

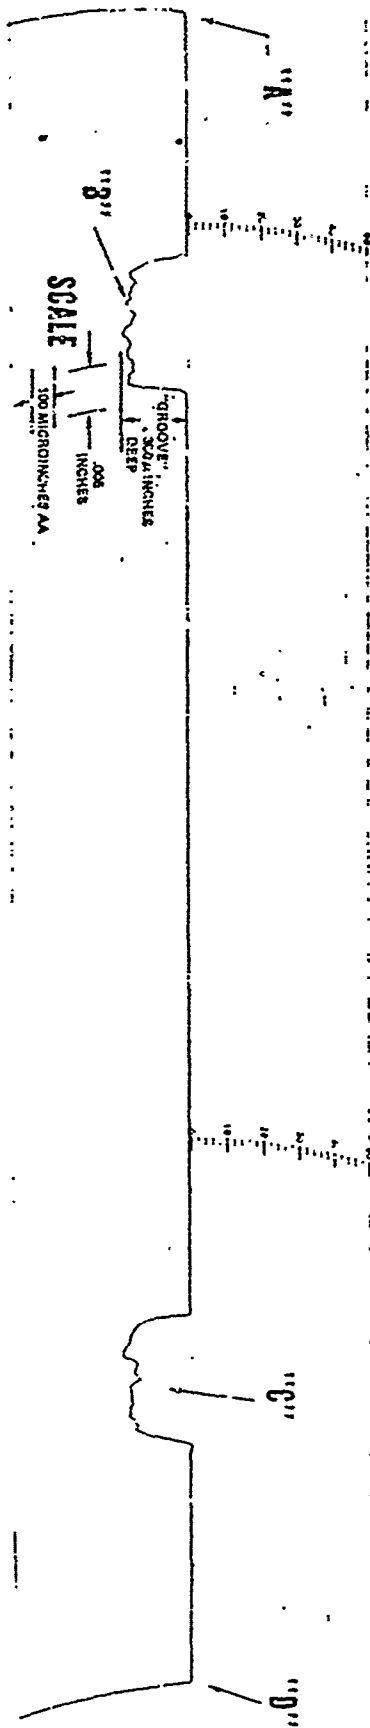
Figure 14. Profile of Tracer, K-36 Popper, Post-Test 14.
56 Q

The seat and poppet are shown in Figures 12 and 13, respectively. Figure 14 is a proficorder trace of the poppet sealing surface which clearly shows the 300 μ inch groove that was worn into it.

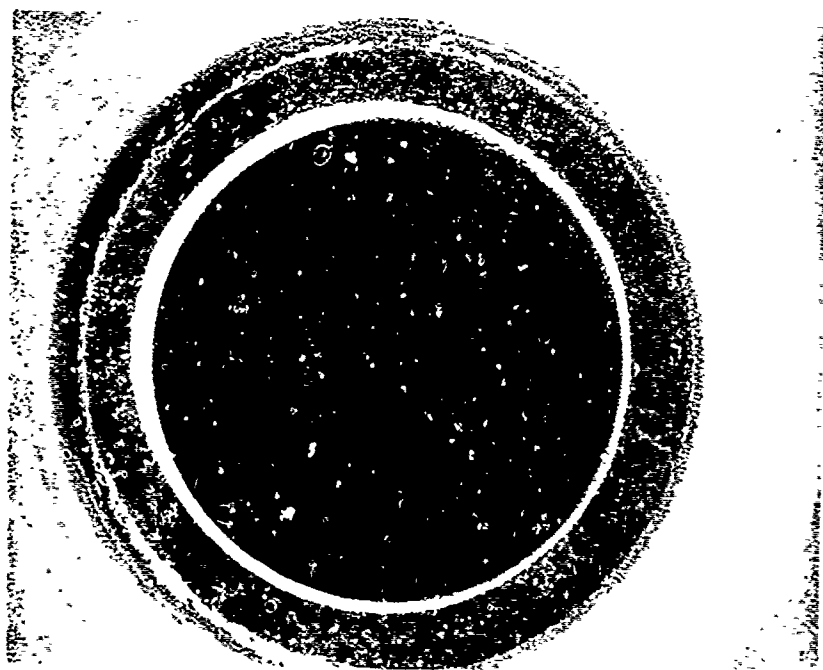
Figure 17. Seat, B₄C, Post-Test 17 (25X)

Based upon the results of this test, boron carbide may be considered to be an acceptable seat and poppet material for this application. Figures 17 and 18 are photos of the boron carbide hardware after test 17. Many tiny holes are readily visible on the sealing surfaces themselves, but apparently too few of the holes are interconnected sufficiently to create leakage paths which extend entirely across the seat. This test substantiated the selection of boron carbide as an acceptable material by Marquardt in Contract F04611-70-C (Reference 3).

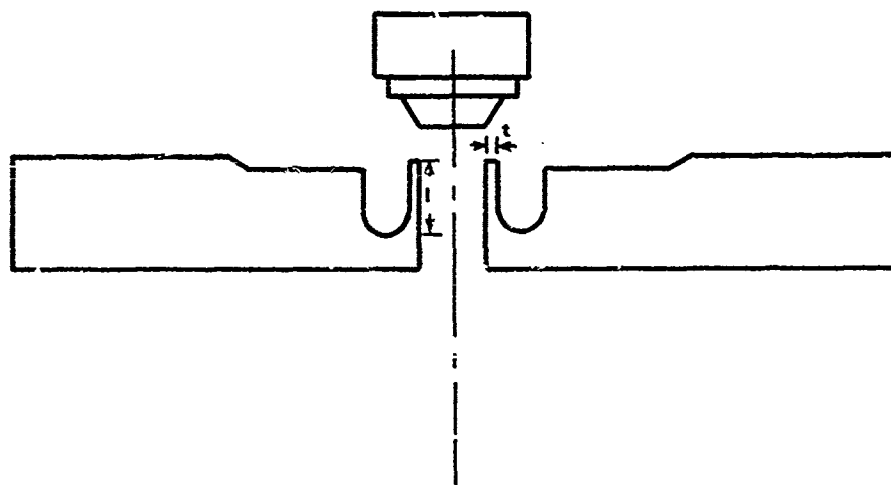
Figure 29. Schematic, AFRPL Conical Poppet/Lip-Seal Design

Figure 29 depicts schematically the new design selected. This design differed from the original Moog design of Figure 25 by two key parameters. The l/t ratio (lip "length" to lip "thickness") was increased by approximately 8 percent in hope of increasing the flexing tendencies of the sealing area. Similarly, to reduce the scrubbing of the inner lip edge, the initial impact angle (Figure 30) between the poppet and seat (θ) was reduced approximately 15 percent.

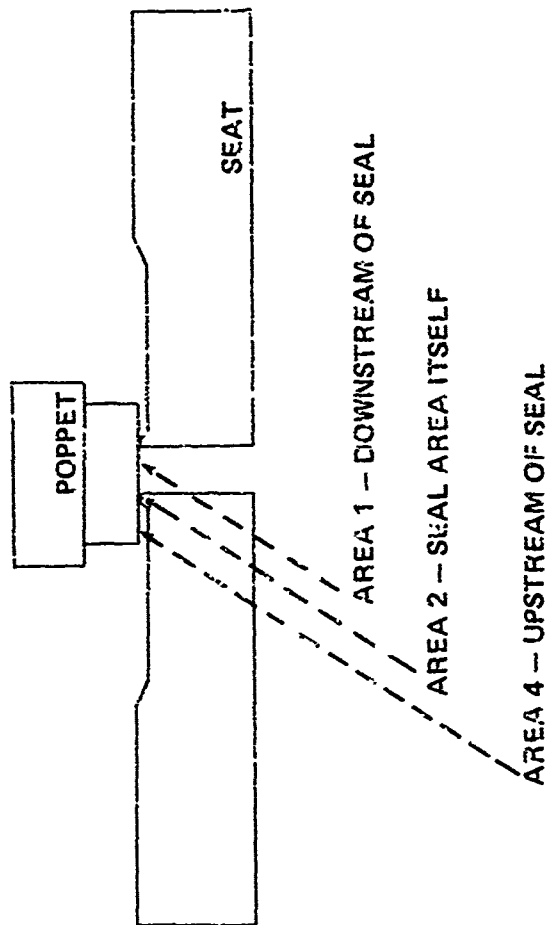
Figure 54. Schematic, Seat/Poppet
In Closed Position

directly exposed to the fire, while most of Area No. 4 was not, being "upstream" of the seat/poppet interface. A simplified schematic of the seat and poppet in the closed position is shown in Figure 54. Damage to the seat and poppet prevented cycle testing of the hardware in ClF_5 .

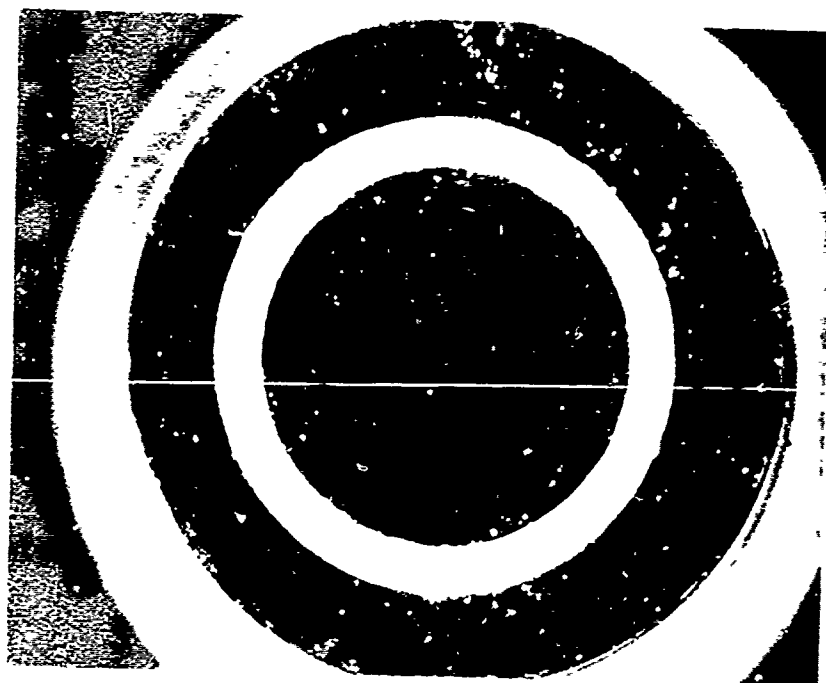
Figure 56. Poppet, 6000Å Chromium on Ni 301,
Post-ClF₅ Testing (20X)

Leakage measurements were made after 25,000, 40,000, and finally 60,000 cycles. Leak rates were 175, 269, and 1,014 scc/hour, respectively. The test was halted at the 60,000-cycle point when leakage had increased dramatically. It is speculated that the chromium coat withstood the dynamic impact conditions in ClF_5 until sometime between 40,000 and 60,000 cycles. At this time, the Duranickel substrate was exposed and the sealing characteristics fell off accordingly. Figures 55 and 56 depict the failed chromium-coated seat and poppet hardware.

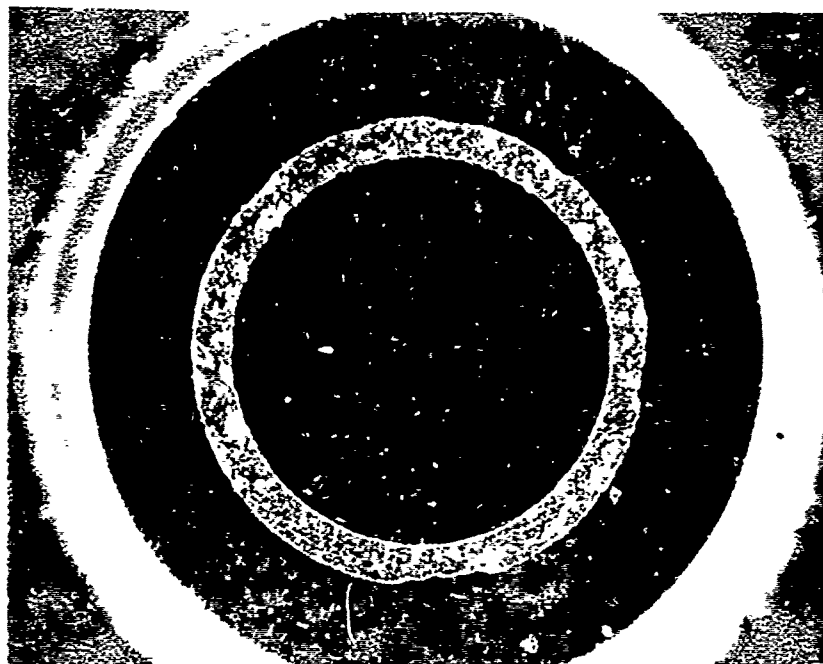
Figure 58. Poppet, 6000Å Tungsten on
Pyromet X-15, Post-ClF₅ Testing (20X)

This final attempt to meet the 100,000-cycle requirement with coated seat and poppet hardware again involved sputter-deposited tungsten. In this case, the substrate material was chosen to be the original fuel-side, iron-based alloy, Pyromet X-15. The objective of the test was to note any significant increase in cycle life due to greater substrate hardness. After 23,000 cycles in ClF_5 , helium leakage went from 20 scc/hour to over 3000 scc/hour, and the test was halted. Figures 57 and 58 show the failed seat and poppet.
